Manhole Inspection Summary

Manhole # S31K__027MH

Printed On: 4/3/2009

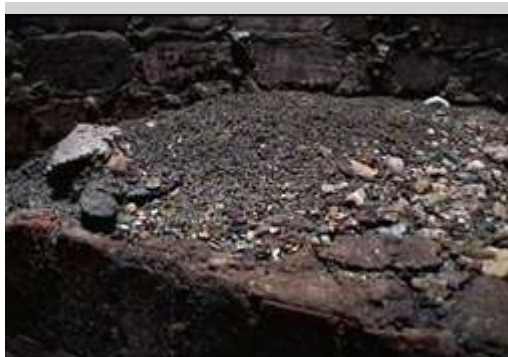
Misc

bench debris

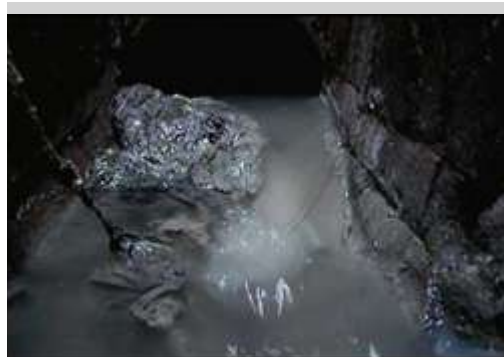
Misc

channel debris

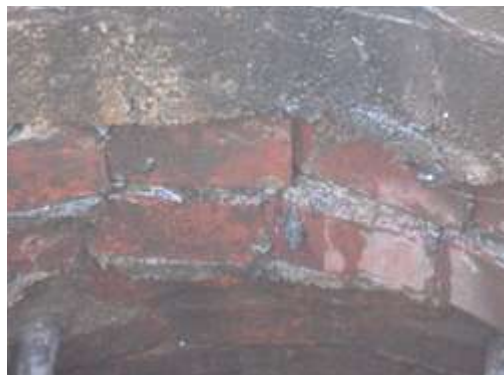
Defect 3

☒ **Leaks**

Infiltration: ☐ None ☒ **Joint** ☐ Cracks ☒ **Mortar** ☐ Roots ☐ Wall

frame infiltration at cover, chimney missing mortar

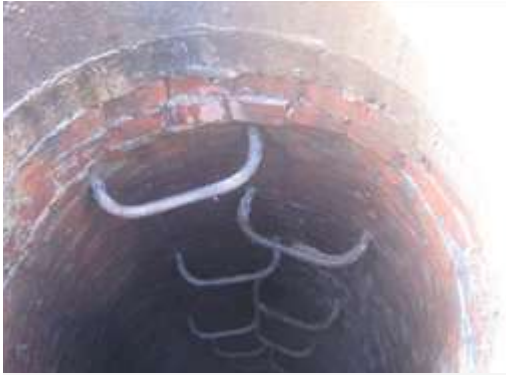
Defect 2

Condition: ☐ Sound ☐ Cracked ☐ Root Intrusion ☒ **Loose Brick** ☐ Deteriorated

chimney loose bricks, infiltration at mortar

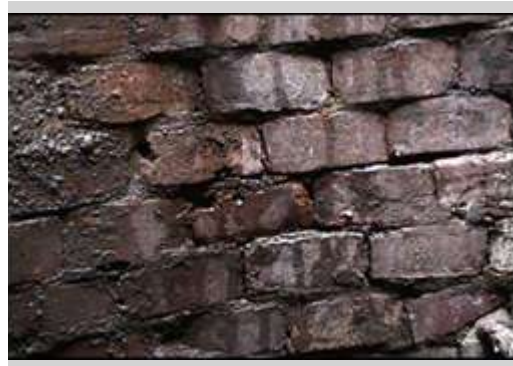
Defect 1

Condition: ☐ Sound ☐ Cracked ☐ Root Intrusion ☐ Loose Brick ☒ **Deteriorated**

Infiltration: ☐ None ☐ Joint ☒ **Cracks** ☒ **Mortar** ☐ Roots ☒ **Wall**

corbel wall infiltration

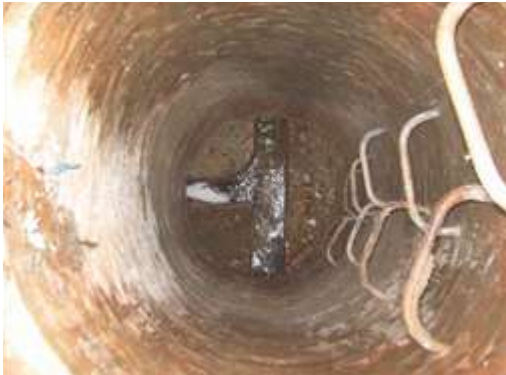
Defect 4

Count: **9** Missing: **0** ☒ **Corroded**

corroded rungs

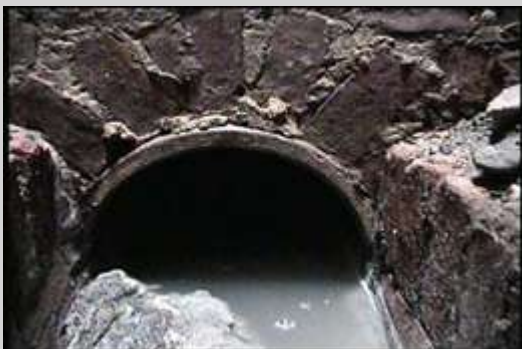
6 O'Clock Inflow

Pipe Height: **10.8** (in.) Rod and Bar (Angled)
Pipe Material: **Clay** ☐ Pipe Lined
Invert Depth: **14.98** (ft.) Flow Characteristics: **Fast**
Deposits: ☐ None ☐ Mud ☐ Sludge ☒ **Debris** ☐ Grease
Silt Depth: **4** (in.) Deposits Extent: **Medium**
Infiltration: **None** Pipe Seal Cond: **Sound**
